NAUGATUCK RIVER BASIN  
WATERTOWN, CONNECTICUT

**MERRIMAN POND DAM**  
**CT 00128**

**PHASE I INSPECTION REPORT**  
**NATIONAL DAM INSPECTION PROGRAM**

JUNE 1980

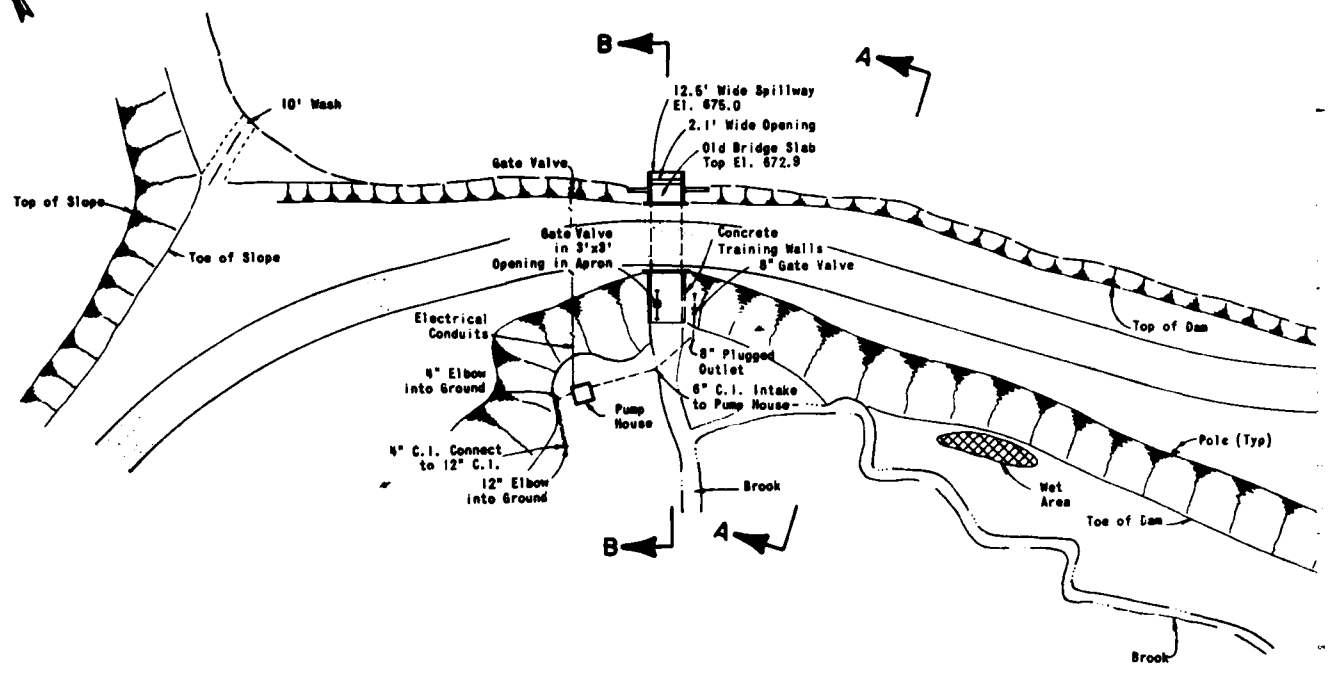
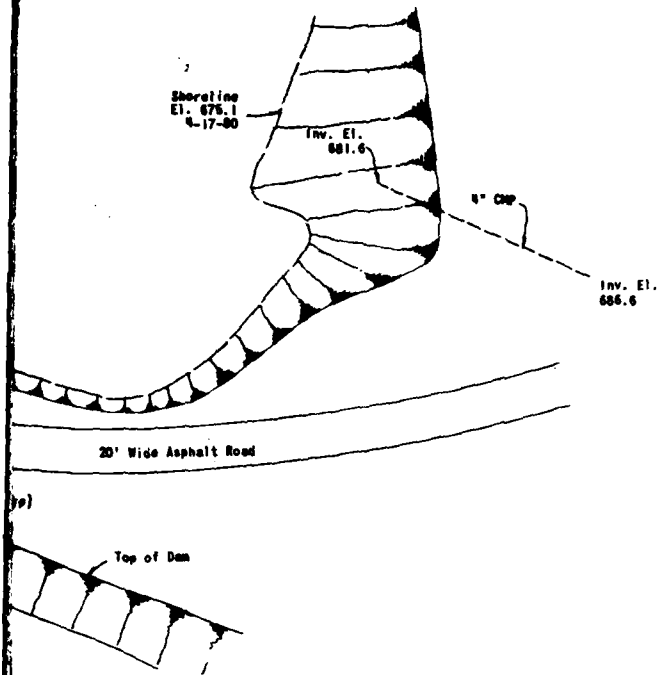
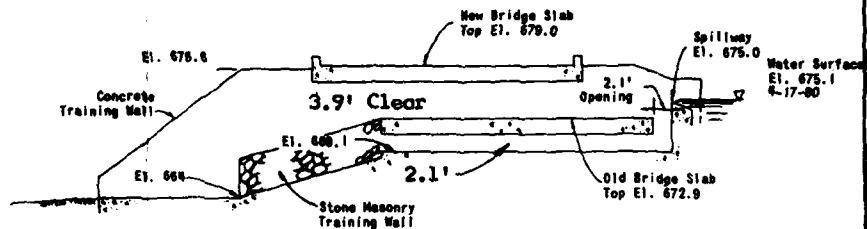
FIGURE 2

| 5. Other: | Unknown gate present in spillway discharge<br>channel. See Figure 2, page B-1 in Appen-<br>dix B. |
